HYUNDAI Technical Service Bulletin	GROUP AUTOMATIC TRANSMISSION	NUMBER 20-AT-014H
	DATE APRIL 2020	MODEL Accent (RB), Azera (TG/HG), Elantra (UD/MD/GD/JK), Santa Fe (CM/AN/NC), Sonata (YF/YF HEV, LF/LF HEV/PHEV), Tucson (LM/TL), Veloster Turbo (FS)
SUBJECT: AUTOMATIC TRANSAXLE OIL TEMPERATURE SENSOR P0711, P0712 & P0713

This TSB supersedes TSB 15-AT-011 to revise the Applicable Vehicles.

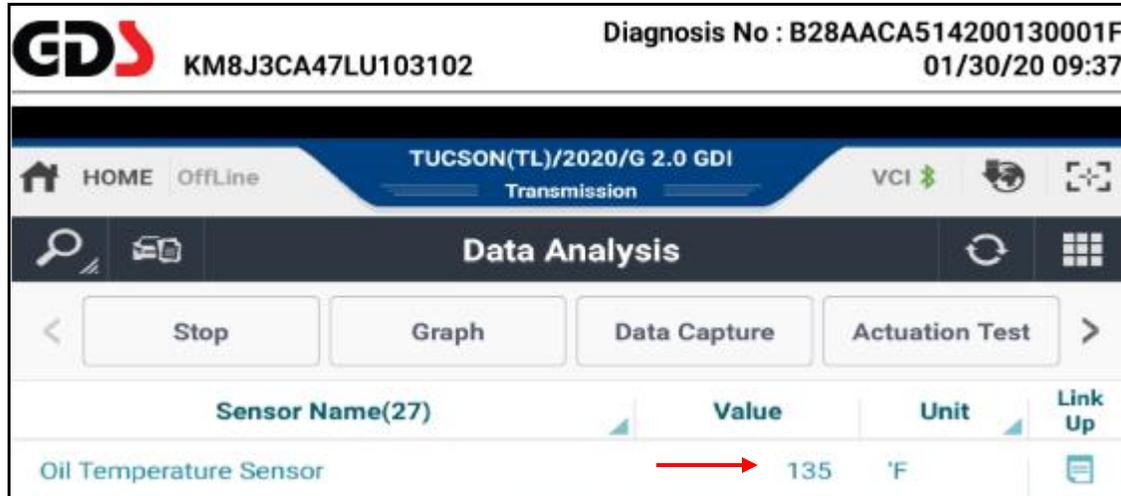
1. Attach a GDS and select **DTC Analysis** and **A/T** menu. Record the DTC and description. Delete the DTC.
2. From the GDS, select **DTC Analysis**, **A/T** menu and **Oil Temperature Sensor**. Drive the vehicle and monitor the sensor.

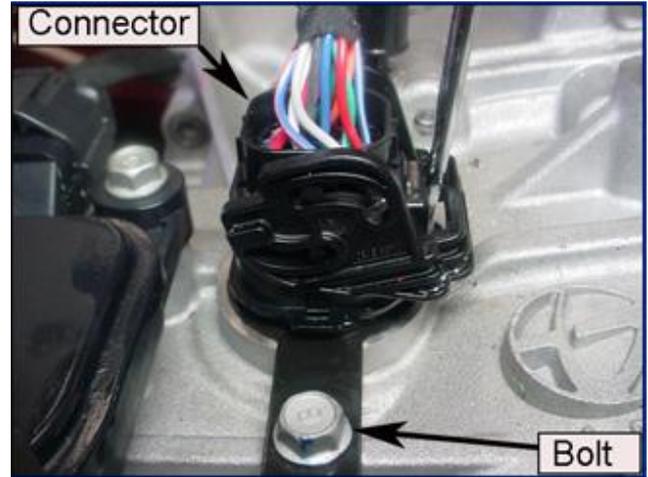
9. Use a screwdriver to release the tab and remove the solenoid connector on top of the case.

Remove the bolt that secures the connector and push the connector into the transmission.

Disconnect the vent hose at the top of the oil pan.

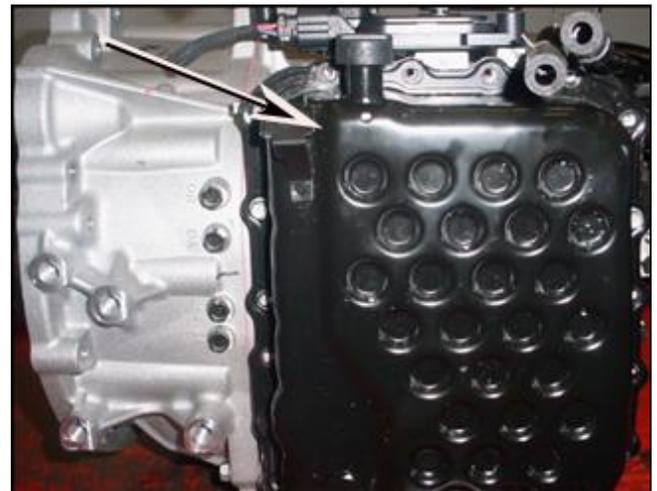
10. Remove the oil pan bolts and remove the pan.

Use a rubber hammer to tap the oil pan cover on a corner until the cover is loose.

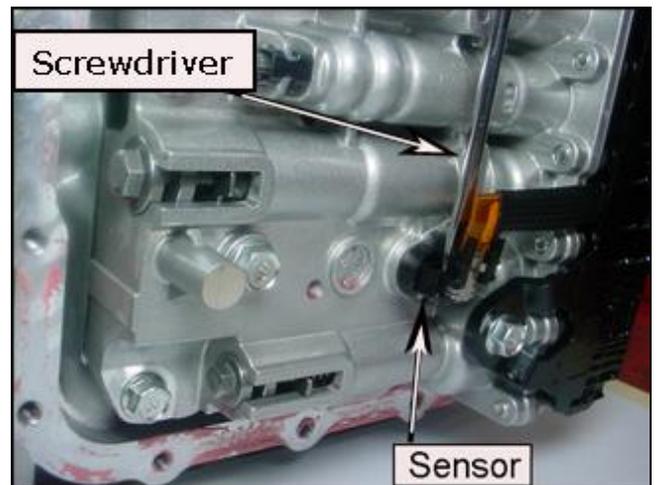
11. Use a small screwdriver to pry the connector from the oil temperature sensor (except for vehicles with integrated oil temperature sensor and harness).

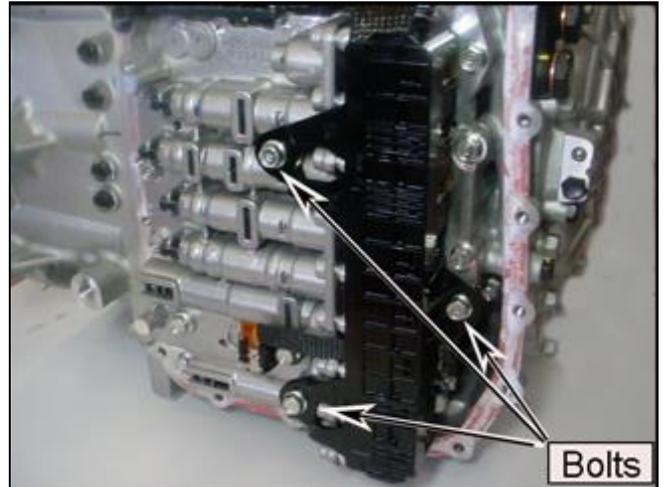
12. Remove three bolts to the solenoid valve connector.

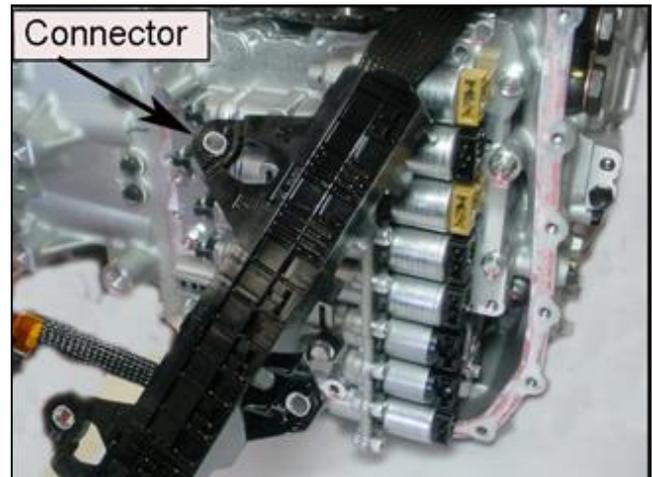
13. Pull the solenoid connector outward and move the connector out of position.

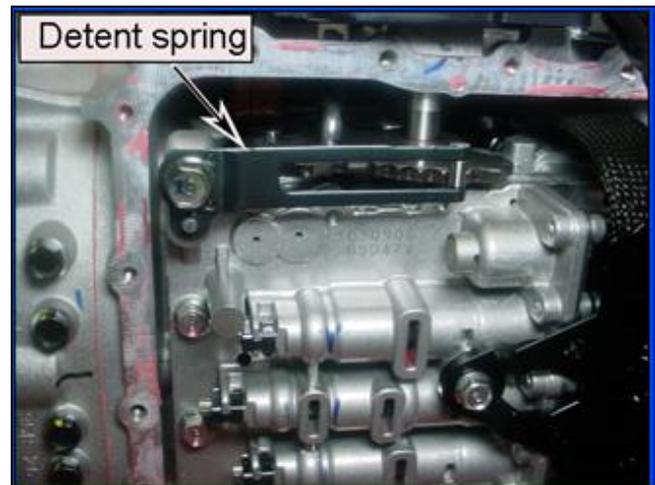
14. Remove the bolt that secures the detent spring and remove the spring.

Torque: 8~11 lb.ft (1.2~1.6 kgf.m/11~15 N.m)

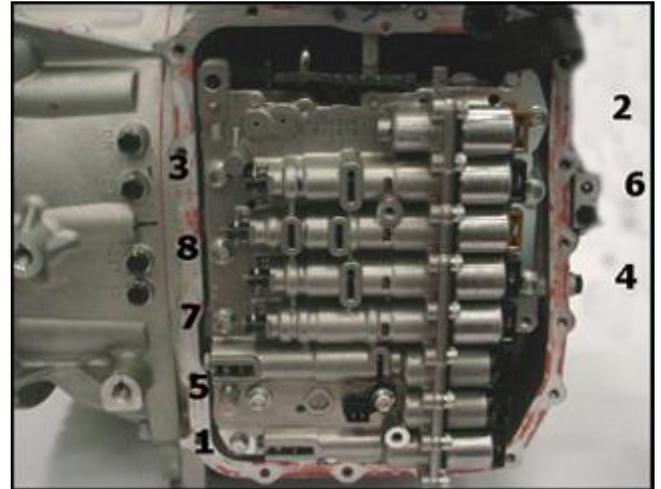
15. Remove 8 bolts in the order shown and remove the valve body.

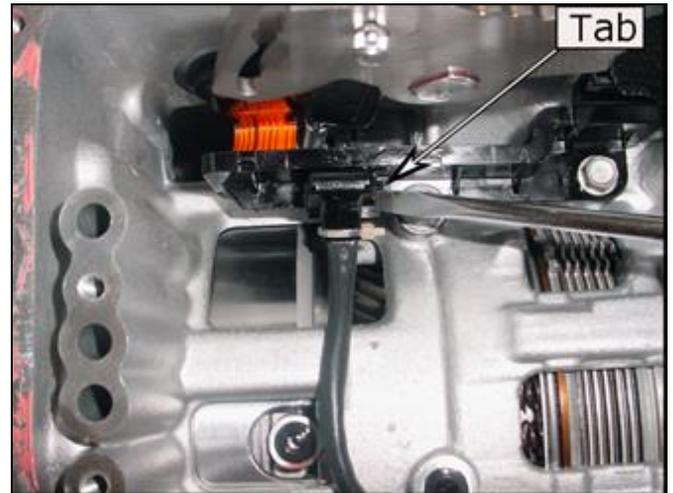
16. Use a screwdriver to depress the locking tab and pull outward on the connector to the input/output speed sensor.

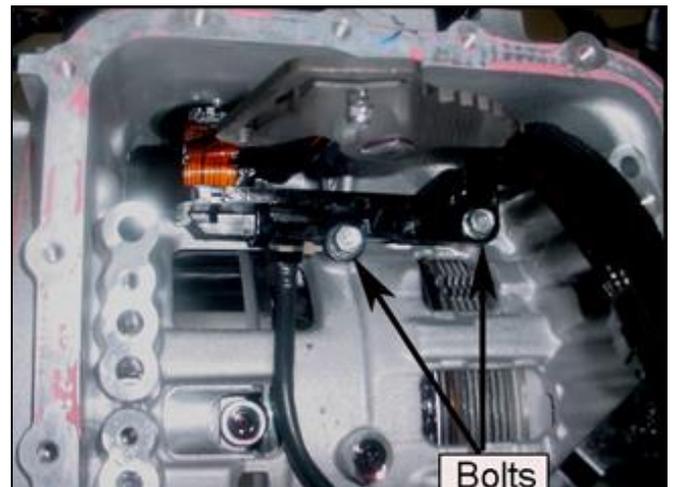
17. Remove two bolts that secure the valve body harness to the case.

Pull the connector downward out of the case.

Install a new harness and insert the connector into the case. Attach the retainer and bolt on top of the case as shown in Step 9.

Install the bolts that secure the harness.

Torque: 6~7 lb.ft (0.9~1.0 kgf.m/8~9 N.m)

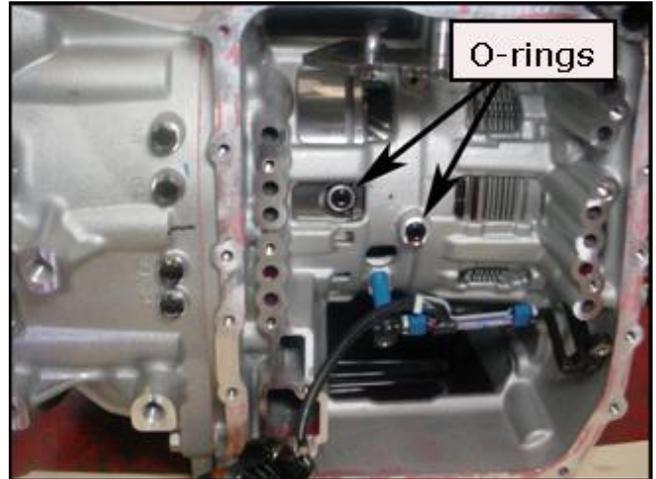
18. Confirm two o-rings are installed correctly in the case.

Reconnect the input and output speed sensor connector to the harness.

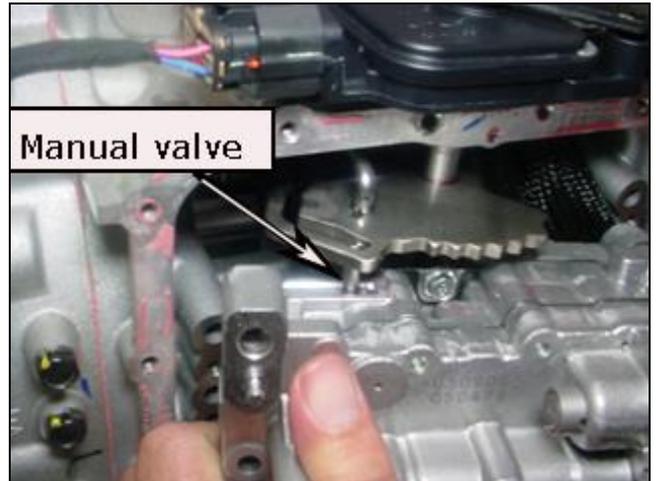
19. Align the manual shaft to the shift lever and install the valve body.

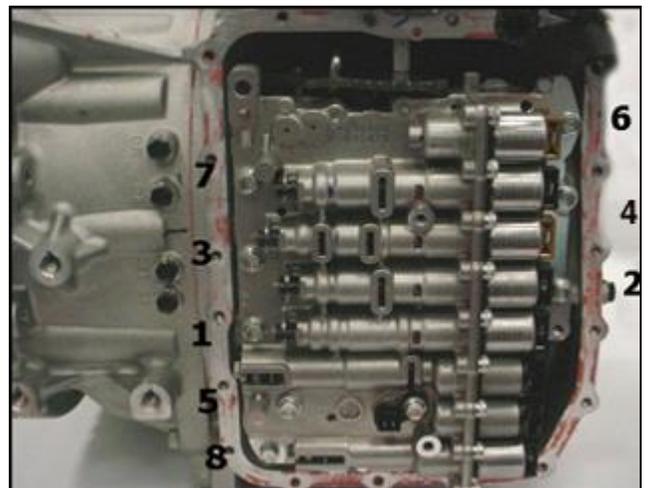
20. Install the valve body bolts and torque the bolts to specification in the order shown.

Torque: 7~9 lb.ft (1.0~1.2 kgf.m, 10~12 N.m)

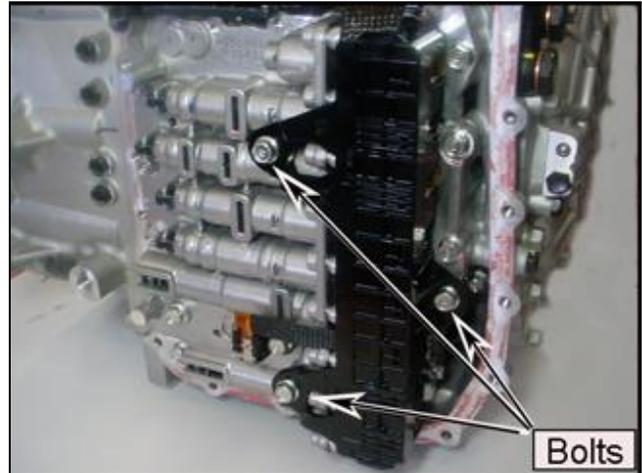
21. Reconnect the solenoid harness to the solenoids and oil temperature sensor.

Install the bolts to the solenoid harness connector and torque to specification.

Torque: 7~9 lb.ft (1.0~1.2 kgf.m, 10~12 N.m)

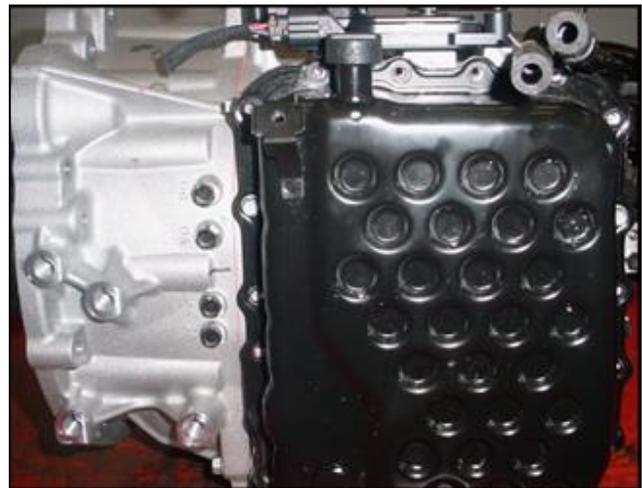
22. **PLASTIC OIL PAN (If equipped):**
Install a new gasket to the oil pan, reinstall the pan and tighten the bolts to specification.

Torque: 6~7 lb.ft (0.9~1.0 kgf.m/8~9 N.m)

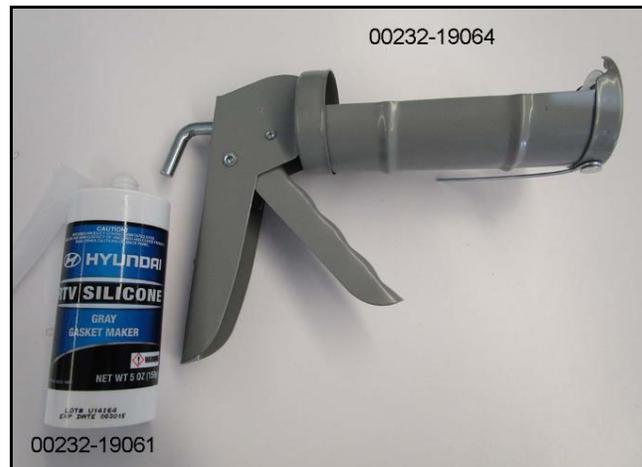
STEEL OIL PAN (If equipped):
Use RTV Silicon Gray, P/N 00232-19061 and a small caulking gun, P/N 00232-19064, or equivalent and apply sealant to the oil pan.

Reinstall the pan.

Torque: 9~11 lb.ft (1.3~1.5 kgf.m/12~15 N.m)

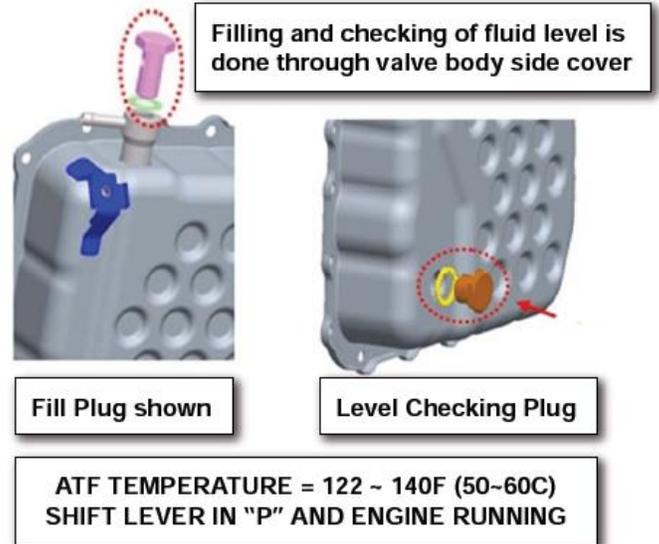
25. Remove the transaxle fill plug.

Use a funnel to add approximately 5~6 quarts of SP4-M ATF through the fill plug opening. Reinstall the fill plug.

Attach the GDS to the DLC and select vehicle, A/T menu, Current Data and **Oil Temperature Sensor**.

Start the engine and shift to Park. When the ATF is **122°F~140°F (50~60°C)**, remove the level checking plug. The level is correct when oil flows out of the level checking plug in a thin steady stream.
